Yorba Linda Water District  
Asset Management Plan Update

REPORT  
2018 ASSET MANAGEMENT PLAN

FINAL | July 6, 2018

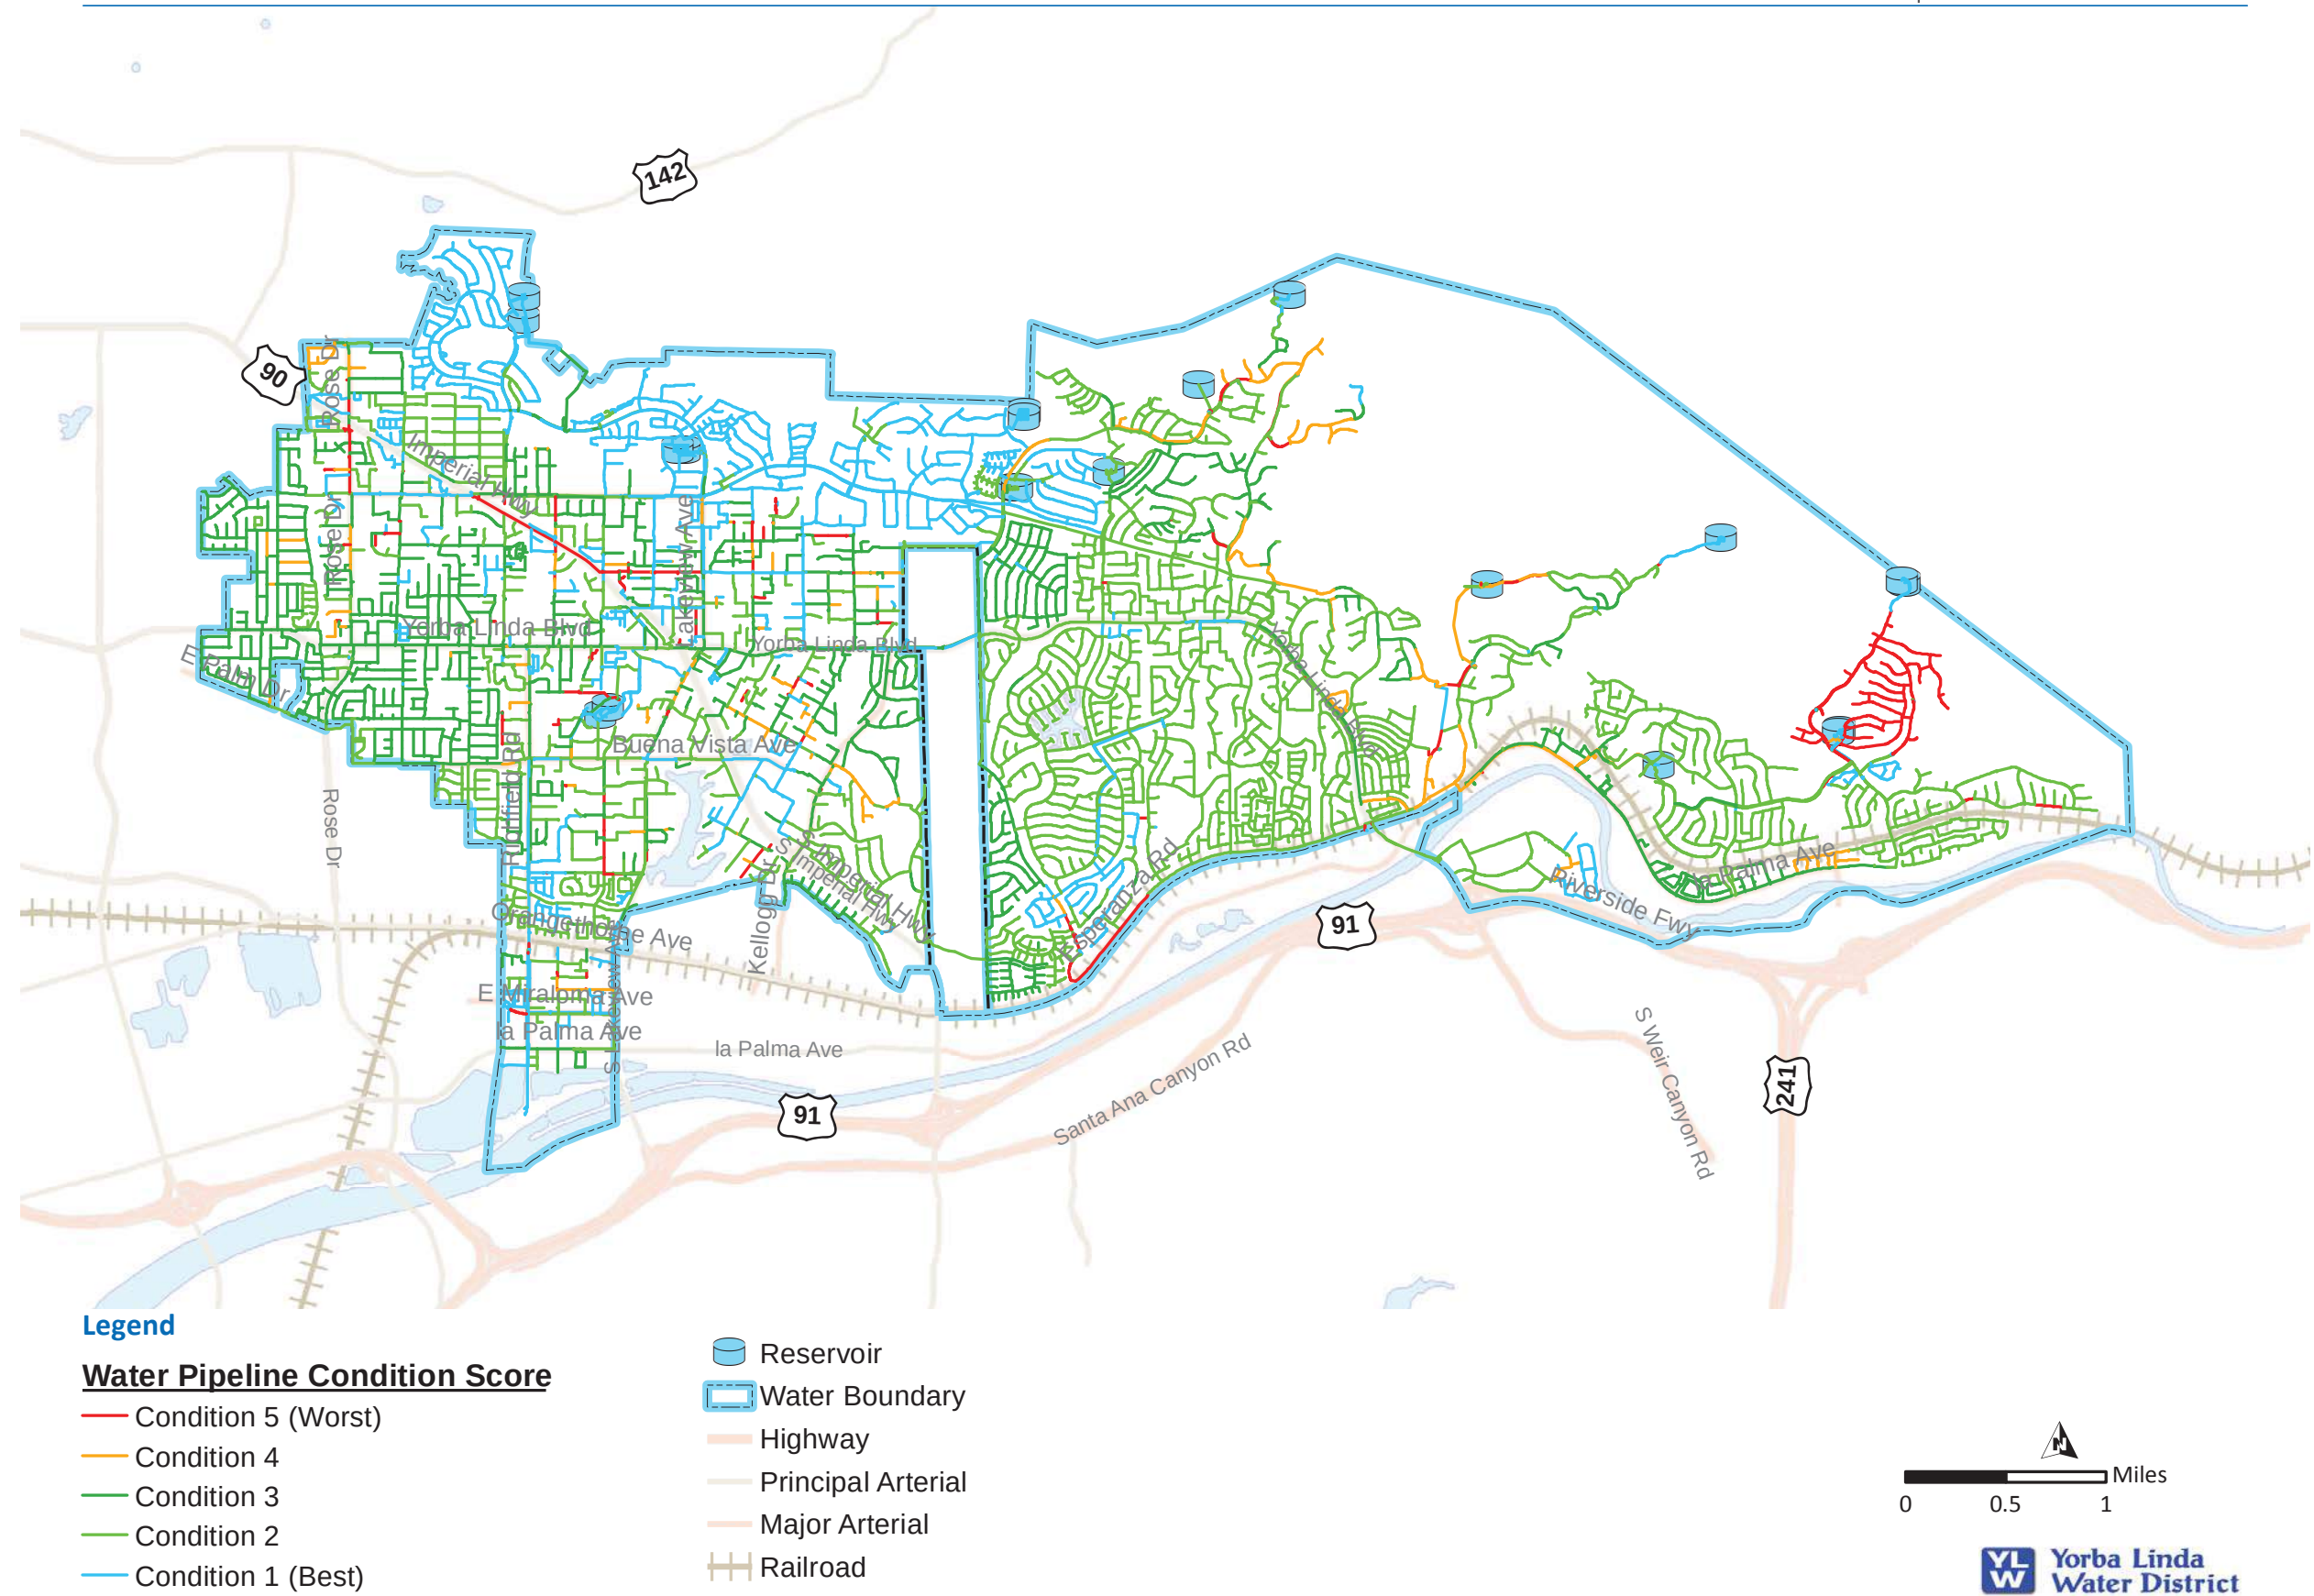
Figure 3.2 Water Pipeline Condition Map

In contrast, the wastewater pipelines are predominately rated condition 2, with small stretches of condition 4 or 5 pipes scattered throughout the service area (as seen in Figure 3.3). Force mains are condition 3 or 4, based on age.
